AFRL-ML-WP-TR-2000-4097

**EFFECTS OF BALLISTIC IMPACT DAMAGE
ON FATIGUE CRACK INITIATION IN
Ti-6Al-4V SIMULATED ENGINE BLADES**

APRIL 2000

Thesis submitted to the School of Engineering University of Dayton

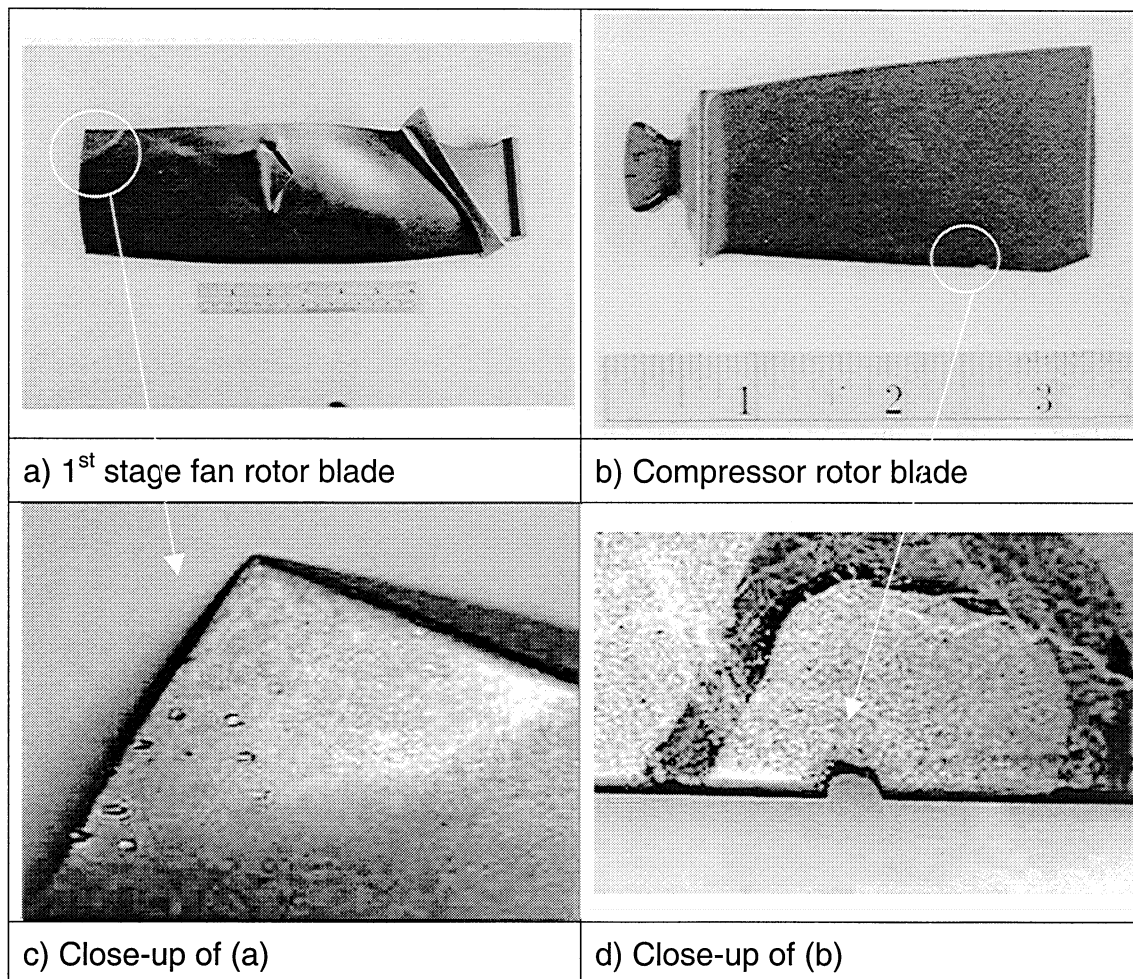
Figure 1: In-service FOD (blades from the F-110-GE-100 engine)

blended out by filing the blade². In addition, if the damage depth exceeds the repairable limit, the engine is pulled out of the aircraft and the blade is replaced. If the FOD depth found on the 1st stage fan rotor blade exceeds the serviceability limit shown in Table 1, the 2nd and 3rd stage rotor blades must be inspected using a device called a borescope, shown in Figure 2. This device utilizes fiber optics in order to view the internal engine components⁵.

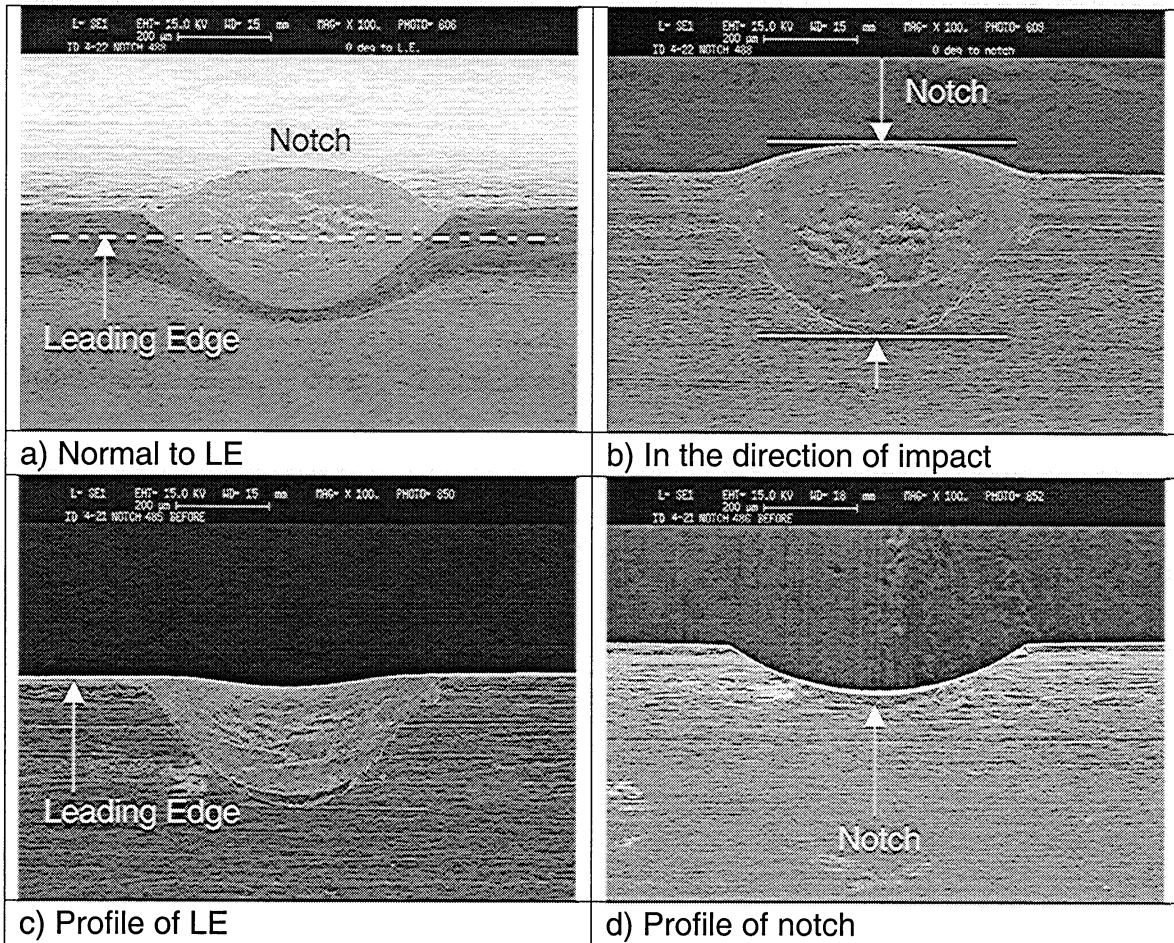
Figure 11: Un-failed notch for sample 4-22, with a sharp LE and a 30° impact

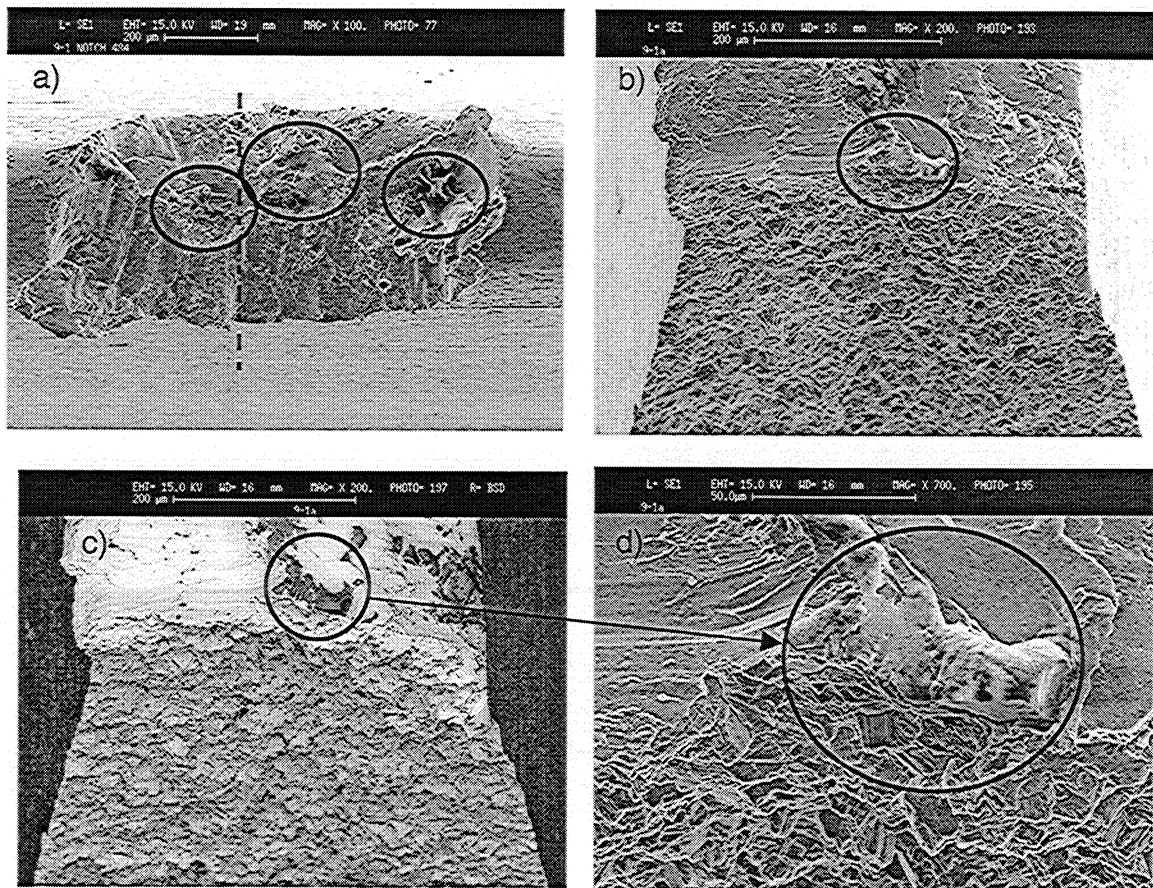
Figure 25: Sample 9-1, 30° impact; a) pre-fracture photo, b) post-fracture, c) backscatter detector image of b, d) close-up of b and c. Embedded glass is indicated by the circle,.
